UPPER SAN JACINTO RIVER BASIN REGIONAL SEDIMENTATION STUDY

Technical Memorandum 3

Annual Sediment Supply and Storage

December 2023

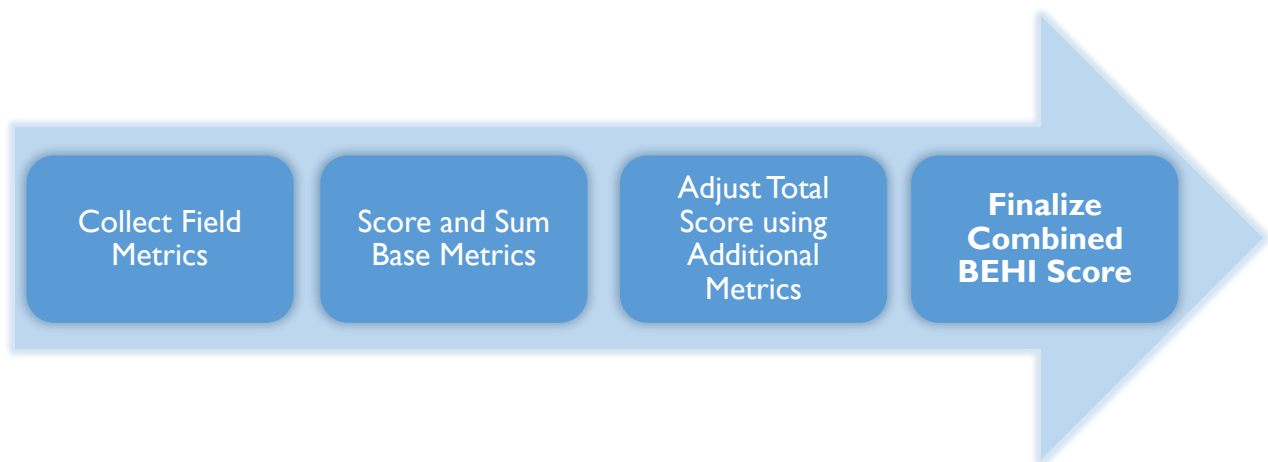
Figure 2. BEHI Process

The BEHI methodology uses field data to determine expected erosion rates at a specific streambank. The process by which BEHI scores are determined is summarized in Figure 2.

The initial BEHI inputs are obtained in the field by observing and measuring the following physical metrics:

- **Study Bank Height / Bankfull Height** (Study bank height divided by bankfull height or depth. The bankfull height is the height at which flow would start to overtop the banks and begin to cause flooding, assuming there is an active floodplain).
- **Root Depth / Study Bank Height** (Average vegetation rooting depth divided by study bank height).
- **Percent Root Density** (Estimated proportion of the bank covered and protected by plant roots).
- **Bank Angle** (in degrees).
- **Percent Surface Protection** (Proportion of total bank covered by vegetation, rock, logs, etc.).

The numeric values of the metrics are then converted to a BEHI rating. The ratings range from very low to extreme and each has a corresponding numeric value ranging from 0 to 10. The numerical values for the first five metrics are then combined into an aggregate score.

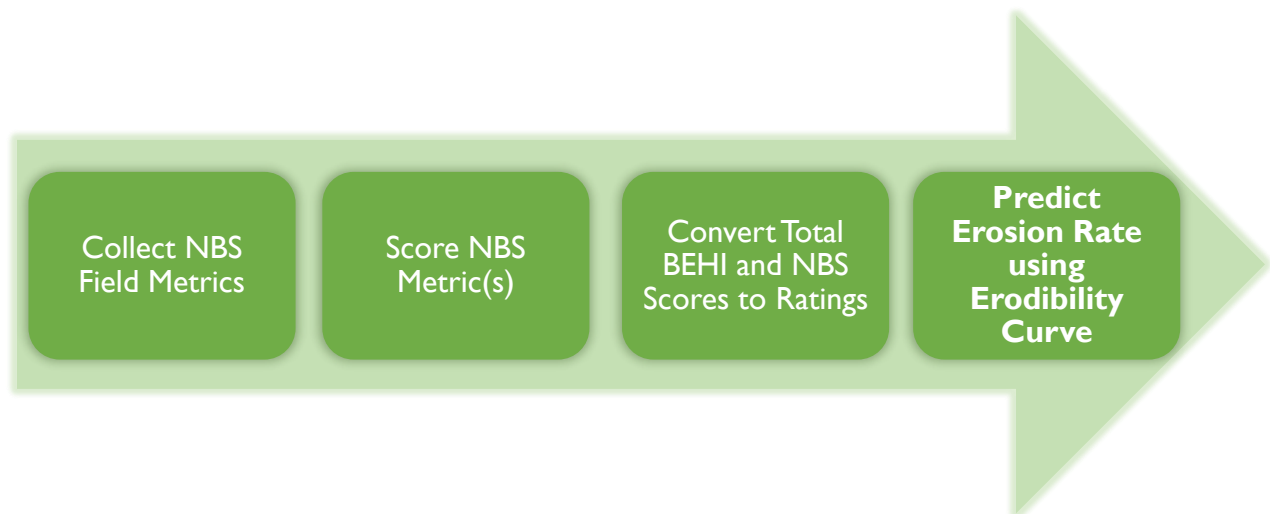
Figure 3. NBS Process and BANCS Erosion Rate Predictions

The second step of the BANCS assessment is to predict NBS, which quantifies the amount of energy distributed to a streambank in the near-bank region that can accelerate erosion. The NBS process is summarized in Figure 3.

NBS scores are based upon one of seven methods, as determined by measurements of channel pattern, dimension, or profile, that best represent site conditions:

1. **Channel Pattern** (used in channels that exhibit transverse bars, split flow or central bars).
2. **Radius of Curvature / Bankfull Width** (radius of the channel bend divided by bankfull width)
3. **Pool Slope / Average Channel Slope** (average pool slopes divided by the average reach slope)
4. **Pool Slope / Riffle Slope** (average pool slope divided by the average slope of riffles)
5. **Near-Bank Maximum Depth / Mean Bankfull Depth** (maximum depth along the study bank divided by average bankfull depth).
6. **Near-Bank Shear Stress / Bankfull Shear Stress** (values calculated from geomorphic survey of channel dimensions and profile).
7. **Velocity Gradient or Profiles** (detailed measurement across the entire channel at high flow).

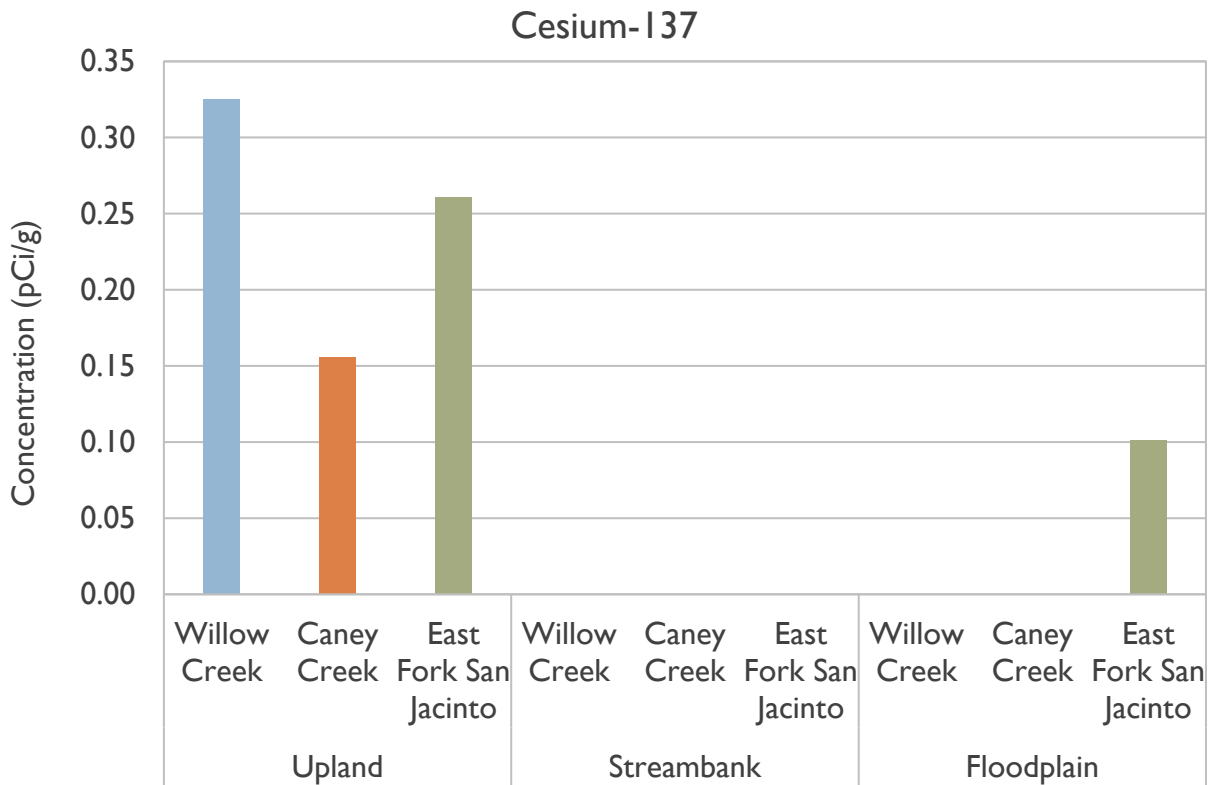
Figure 5. Cs-137 Concentrations for Watershed Samples

Each of the collected samples was sent to a laboratory for gamma spectroscopy analysis to determine concentrations of Cs-137 and Pb-210 in the soil samples. Results, in units of picocuries per gram (pCi/g), are summarized in Figure 5 and Figure 6.

Upland surface sediment samples included detection of both Cs-137 and Pb-210, which is expected, since it is assumed those sediments have been relatively undisturbed for the past 125 years and would have been affected by atmospheric deposition of these radionuclides.

The streambank samples at all three streams include Pb-210 but did not have detectable concentrations of Cs-137, which means that the sediments that make up the current streambanks may have been deposited after the late 1800s but before 1954-63. This result may be an indicator of prior anthropogenic impacts, where upland sediments were washed into floodplains, likely as a result of poor land use practices in the late 1800s and early 1900s, and streams then cut through the newly deposited, unconsolidated sediments. The current streambanks are composed of these relatively recent, unconsolidated sediments.

These results, when evaluated in tandem with the isotope results shown in Figure 5 and Figure 6, suggest that the Willow Creek and Caney Creek floodplain sediments originate predominantly – and perhaps entirely – from streambank sources. The floodplain sample at the East Fork San Jacinto River likely contains sediments from both streambank and upland sources. The bar deposition results demonstrate the relative tendency of sand to settle out during typical flow conditions. Sand is mobilized only under stormflow conditions and then settles as floodwaters recede and stream velocities decrease. In contrast, baseflows in these streams apparently have sufficient velocity to keep the majority of silt and clay sediments in suspension for downstream transport. Sediment bedload (i.e., sand) transport is discussed in greater detail in TM 4 – Sediment Transport Modeling.

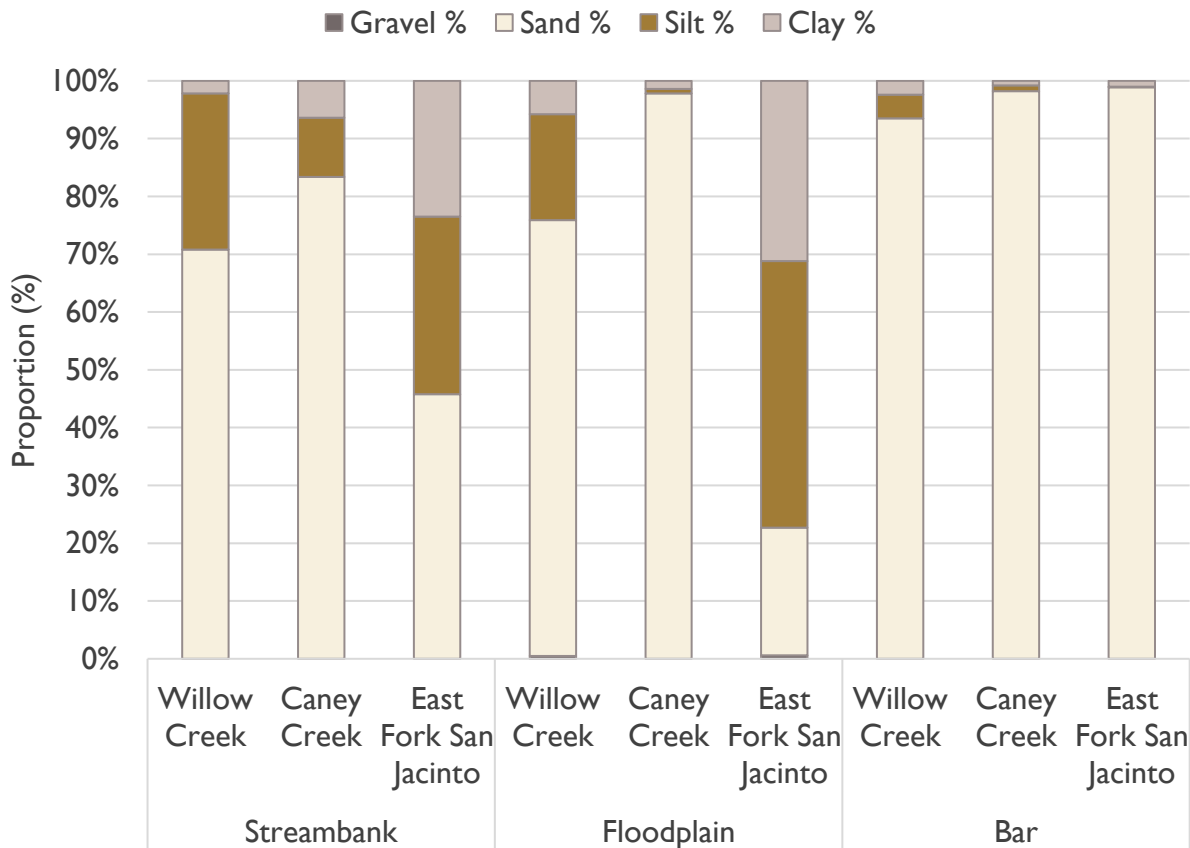
Figure 7. Particle Size Distributions for Watershed Samples

All samples were analyzed by the geotechnical laboratory for particle size distribution using ASTM Method D422. Sample particle size distributions are summarized in Figure 7.

As can be seen in the figure, sand was the most dominant component in the majority of the samples, and it exceeded 70% in seven of the nine sampled locations. Only the streambank and floodplain samples from the East Fork San Jacinto River had more than 50% fine-grained (i.e., silt and clay) composition. All samples contained less than 1% gravel, and it is believed that the trace gravel that was measured originated from anthropogenic sources (e.g., road shoulders, rip rap or other stabilization backfill, etc.).

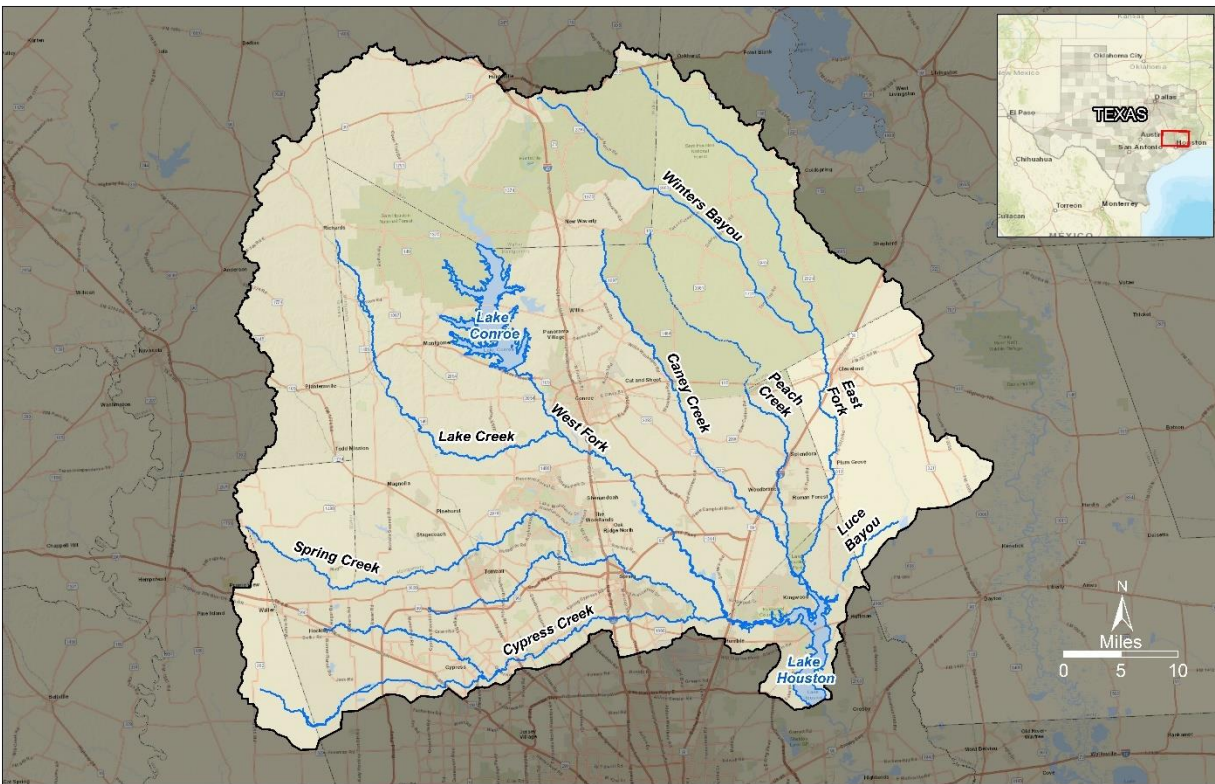
Figure 8. Lake Houston Location within the USJRB

Lake Houston is relatively wide and shallow, with a maximum depth of less than 40 ft and an average depth of 12 ft. The main body of the lake has two major vehicular crossings: Farm-to-Market (FM) 1960, a roadway crossing the lake's northern portion, and a Union-Pacific Railroad (UPRR) bridge crossing roughly at the lake's midpoint (see Figure 9). The majority of FM 1960, including the portion in the center of the lake, was constructed on natural ground and/or fill. It includes two bridges on opposite sides of the lake spanning the historical riverbeds of the San Jacinto's two major branches: West Fork San Jacinto River and East Fork San Jacinto River.

As shown in the figure, the vast majority of flows entering Lake Houston leave the lake by flowing over the Lake Houston Dam to the Lower San Jacinto River. Although the dam has gates that can be used to adjust lake water levels, the majority of outflow is via the uncontrolled spillway. For the purposes of this Study, the USJRB refers to the entire basin above the Lake Houston Dam, as shown in Figure 8.

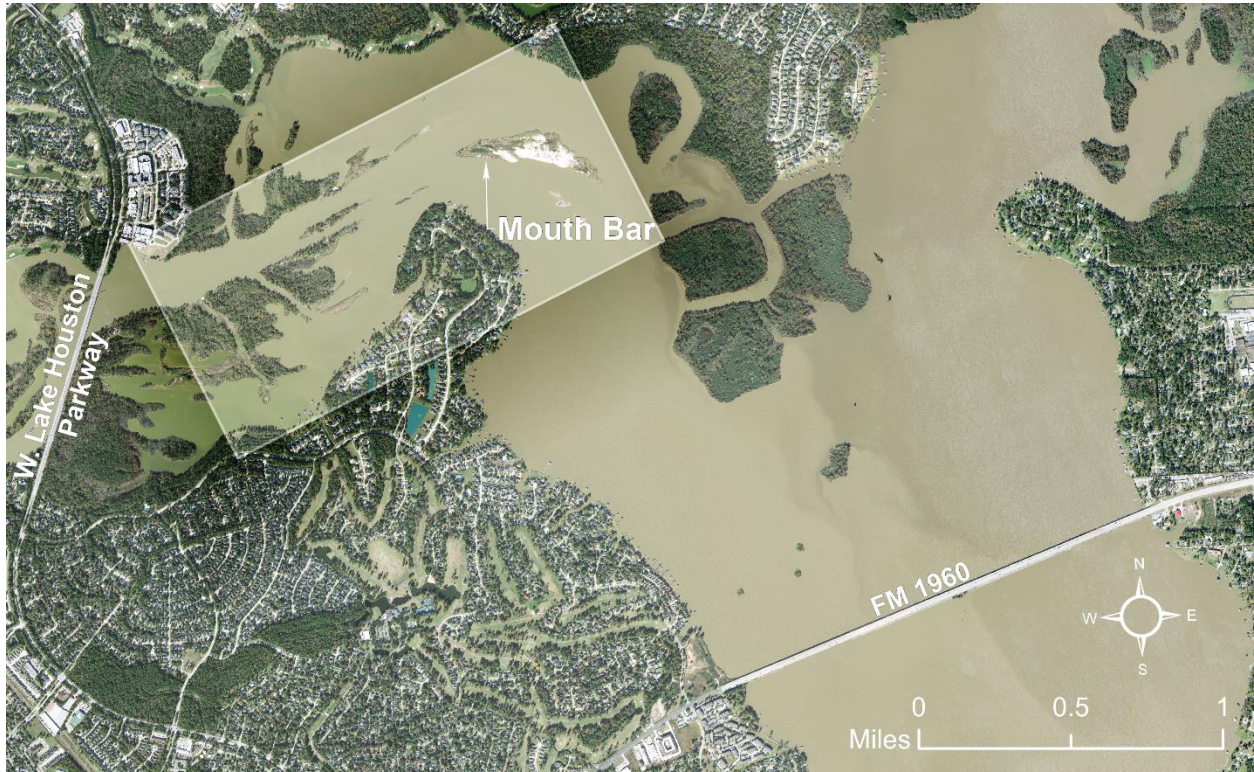
Figure 11. Lake Houston West Inlet Depositional Zone

The approximate locations of the likely depositional zones identified by the modeling for the west inlet and north inlet are shown in Figure 11 and Figure 12, respectively. In both inlets, the identified depositional zone is located where the inlets enter the main body of the lake. These are also known locations of sediment deposition. The location identified for the west inlet includes an area of deltaic islands and the West Fork mouth bar, which was recently removed via dredging efforts conducted by the City of Houston. The north inlet location similarly corresponds with deltaic islands where the inlet enters the main body of the lake and where the East Fork mouth bar formed over time.

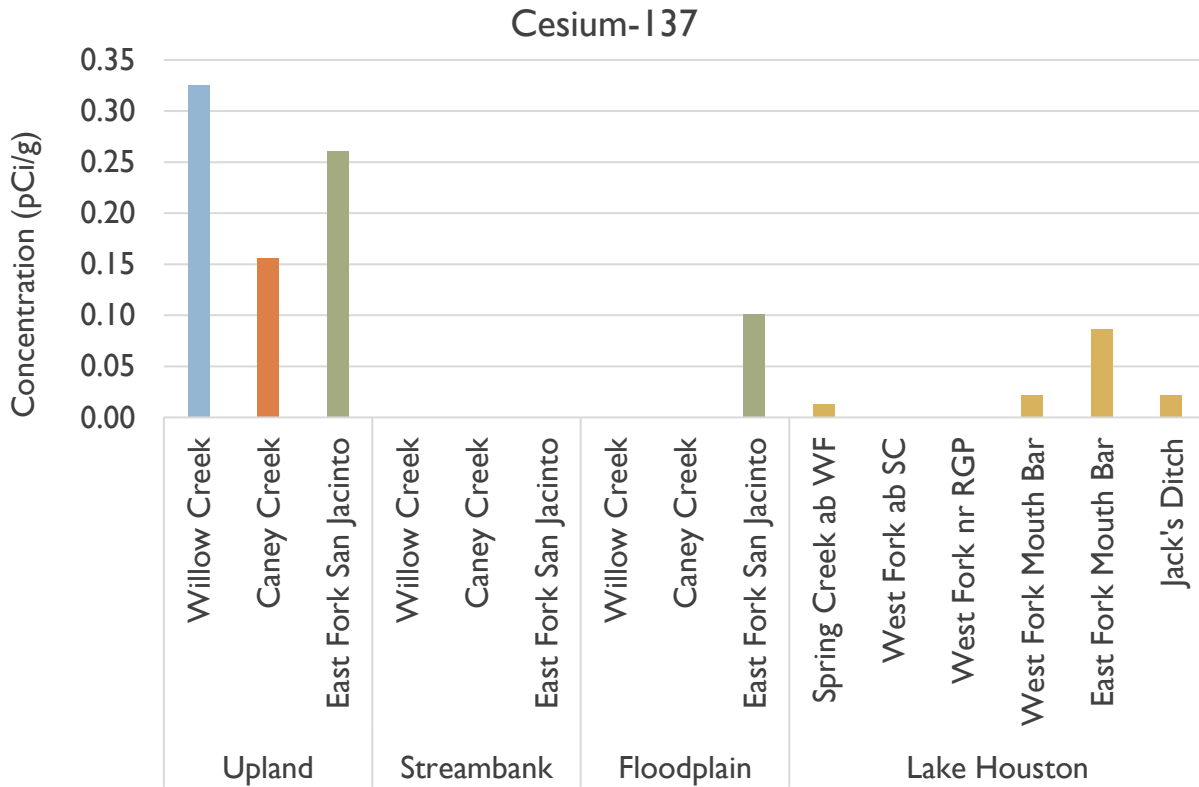
Figure 14. Cs-137 Concentrations for Watershed and Lake Houston Samples

One exception is the relatively higher concentration of Cs-137 at the East Fork Mouth Bar location. Similar to the East Fork San Jacinto floodplain sample discussed in Section 0, it is likely that this location receives a blend of upland and streambank sediments.

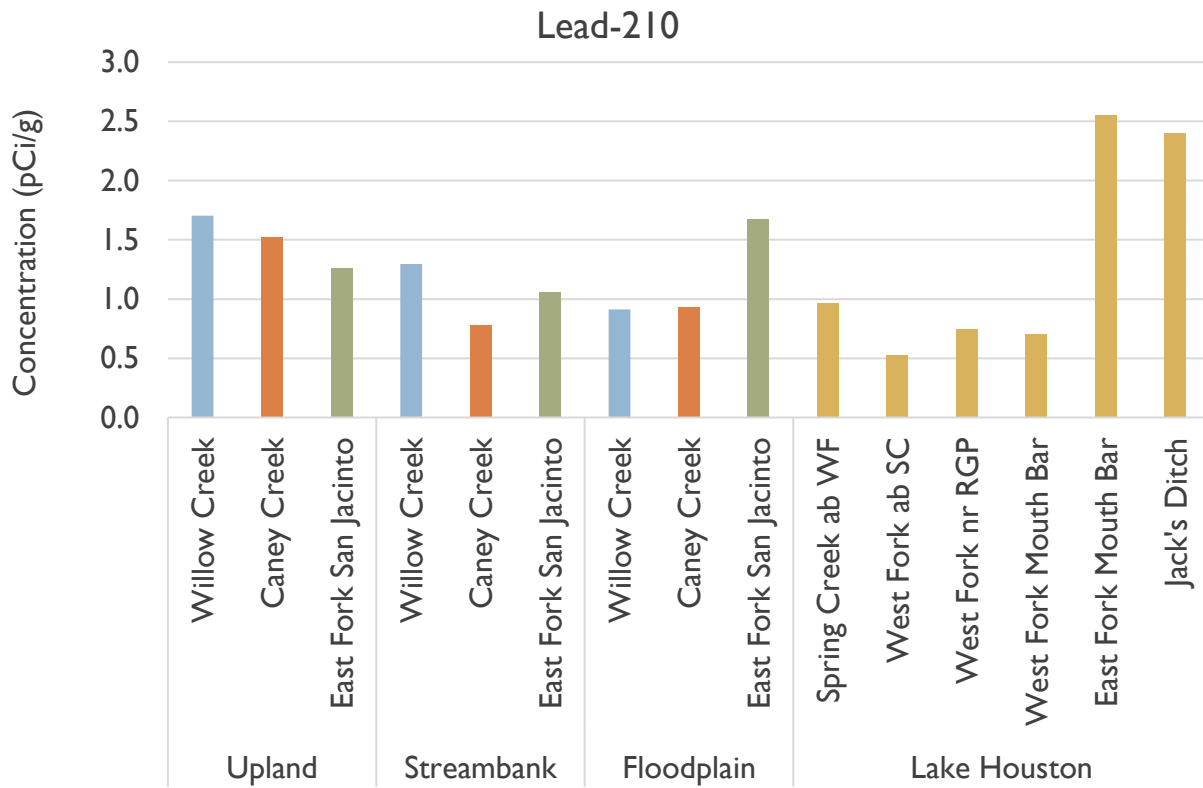
Figure 15. Pb-210 Concentrations for Watershed and Lake Houston Samples

Figure 15 presents the results of Pb-210 analysis for the Lake Houston samples alongside the watershed sample results previously presented in Figure 6. As can be seen in the figure, the four samples from the west inlet (Spring Creek ab WF, West Fork ab SC, West Fork nr RGP, West Fork Mouth Bar) all had relatively low Pb-210 concentrations, while the East Fork Mouth Bar and Jack's Ditch (i.e., lower Lake Houston) samples had the highest reported concentrations of all samples collected in this study.

Similar to the elevated concentration in the East Fork San Jacinto floodplain sediments, the elevated concentrations at these two locations are attributed to their relatively high fine-grain (i.e., silt and clay) sediment composition, as some isotopes are known to bind more readily with fine-grained soils. While the precise upland contribution cannot be directly determined from the isotope concentrations, it is likely that these locations receive a considerably higher proportion of upland sediments than the west inlet locations.

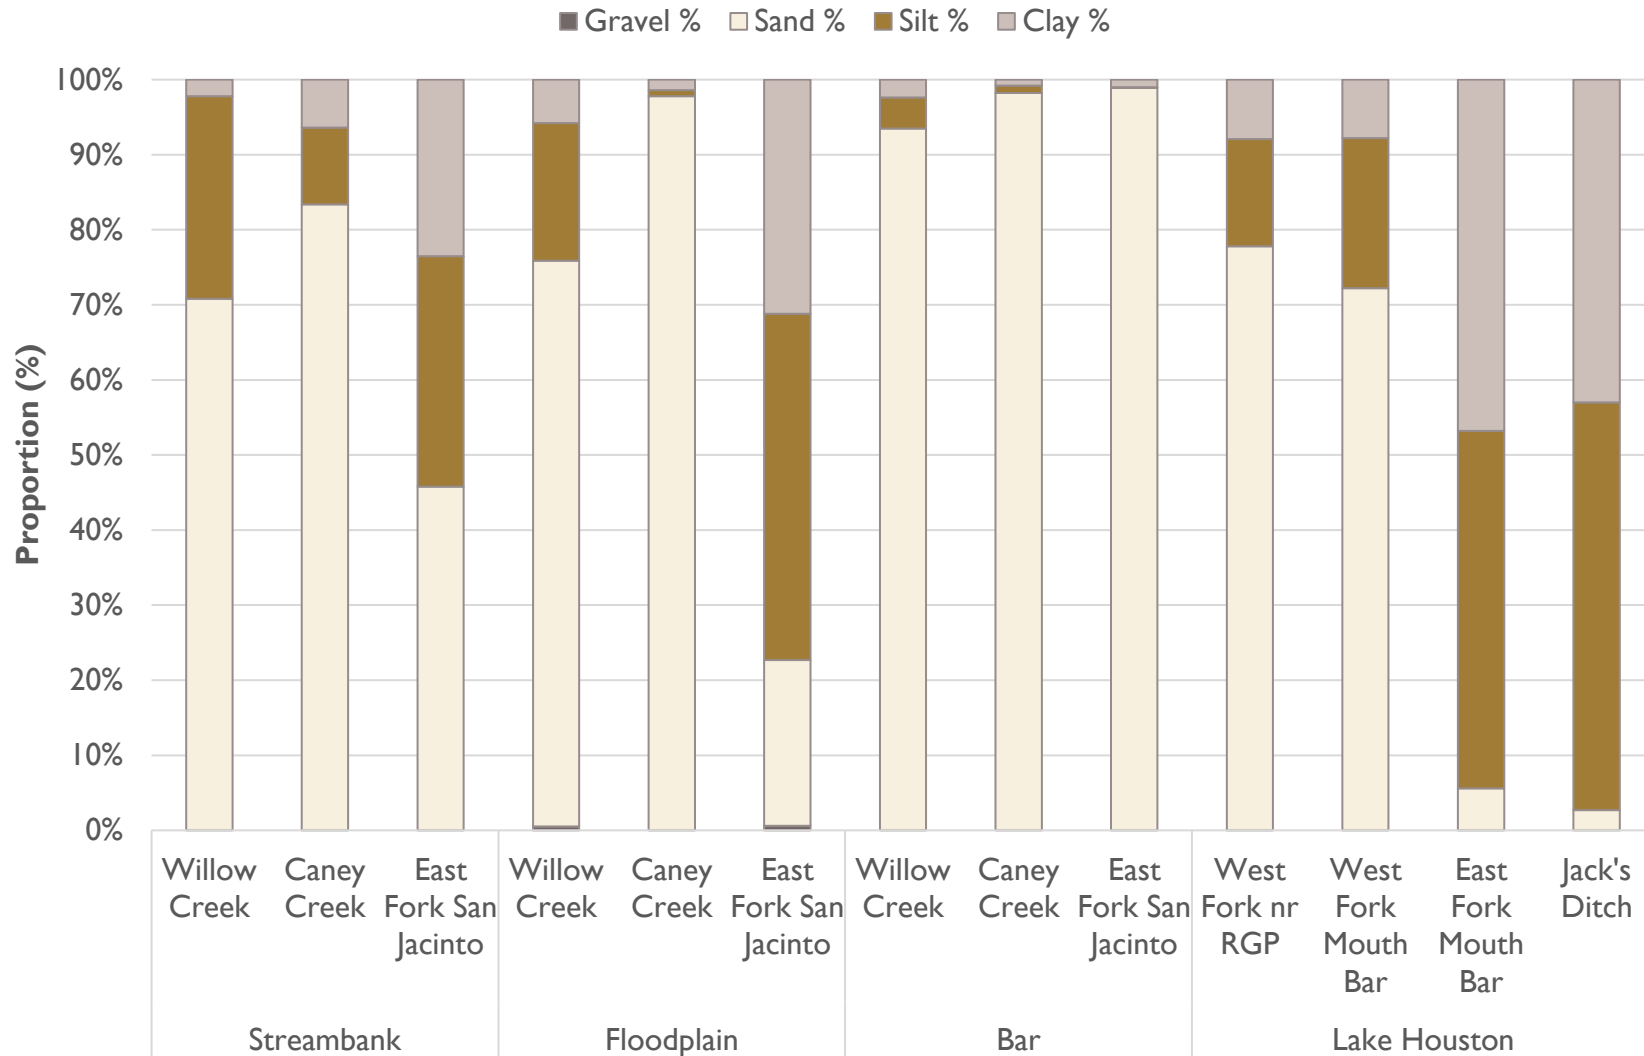
Figure 16. Particle Size Distributions for Watershed and Lake Houston Samples

Figure 16 contains particle size distributions for four Lake Houston lakebed sediment samples. These proportions are shown alongside the watershed sample results (previously presented in Figure 7) to facilitate comparison. Due to sandy sediment composition and stream currents at the Spring Creek ab WF and West Fork ab SC locations, insufficient sample was collected for particle size analysis. However, these samples were anecdotally observed to be predominantly sand, with sand concentrations likely exceeding 80% of the overall sediment sample mass.

The two west inlet samples were predominantly (greater than 70%) sand. These proportions, when considered in tandem with the isotope results, indicate that the west inlet (i.e., West Fork Arm) samples likely originated primarily from eroding streambanks. In contrast, the relatively high proportions of fines in the East Fork Mouth Bar and Jack’s Ditch samples indicate appreciable upland sediment contribution, consistent with the Pb-210 data.

Despite the relative similarities in the Pb-210 concentrations and particle size distributions between the East Fork Mouth Bar and Jack’s Ditch locations, these results do not indicate that Jack’s Ditch sediments originate primarily from the north inlet. Rather, these similarities indicate that similar types of predominantly fine sediments are deposited at these locations, with sand sediments settling out upstream of these locations. Prior modeling work (Coastal Water Authority, 2022) indicated that Jack’s Ditch receives blended flows from all three inlets under most flow conditions. During extreme rainfall events (greater than 6 inches of rainfall), it receives inflow from only the west inlet.

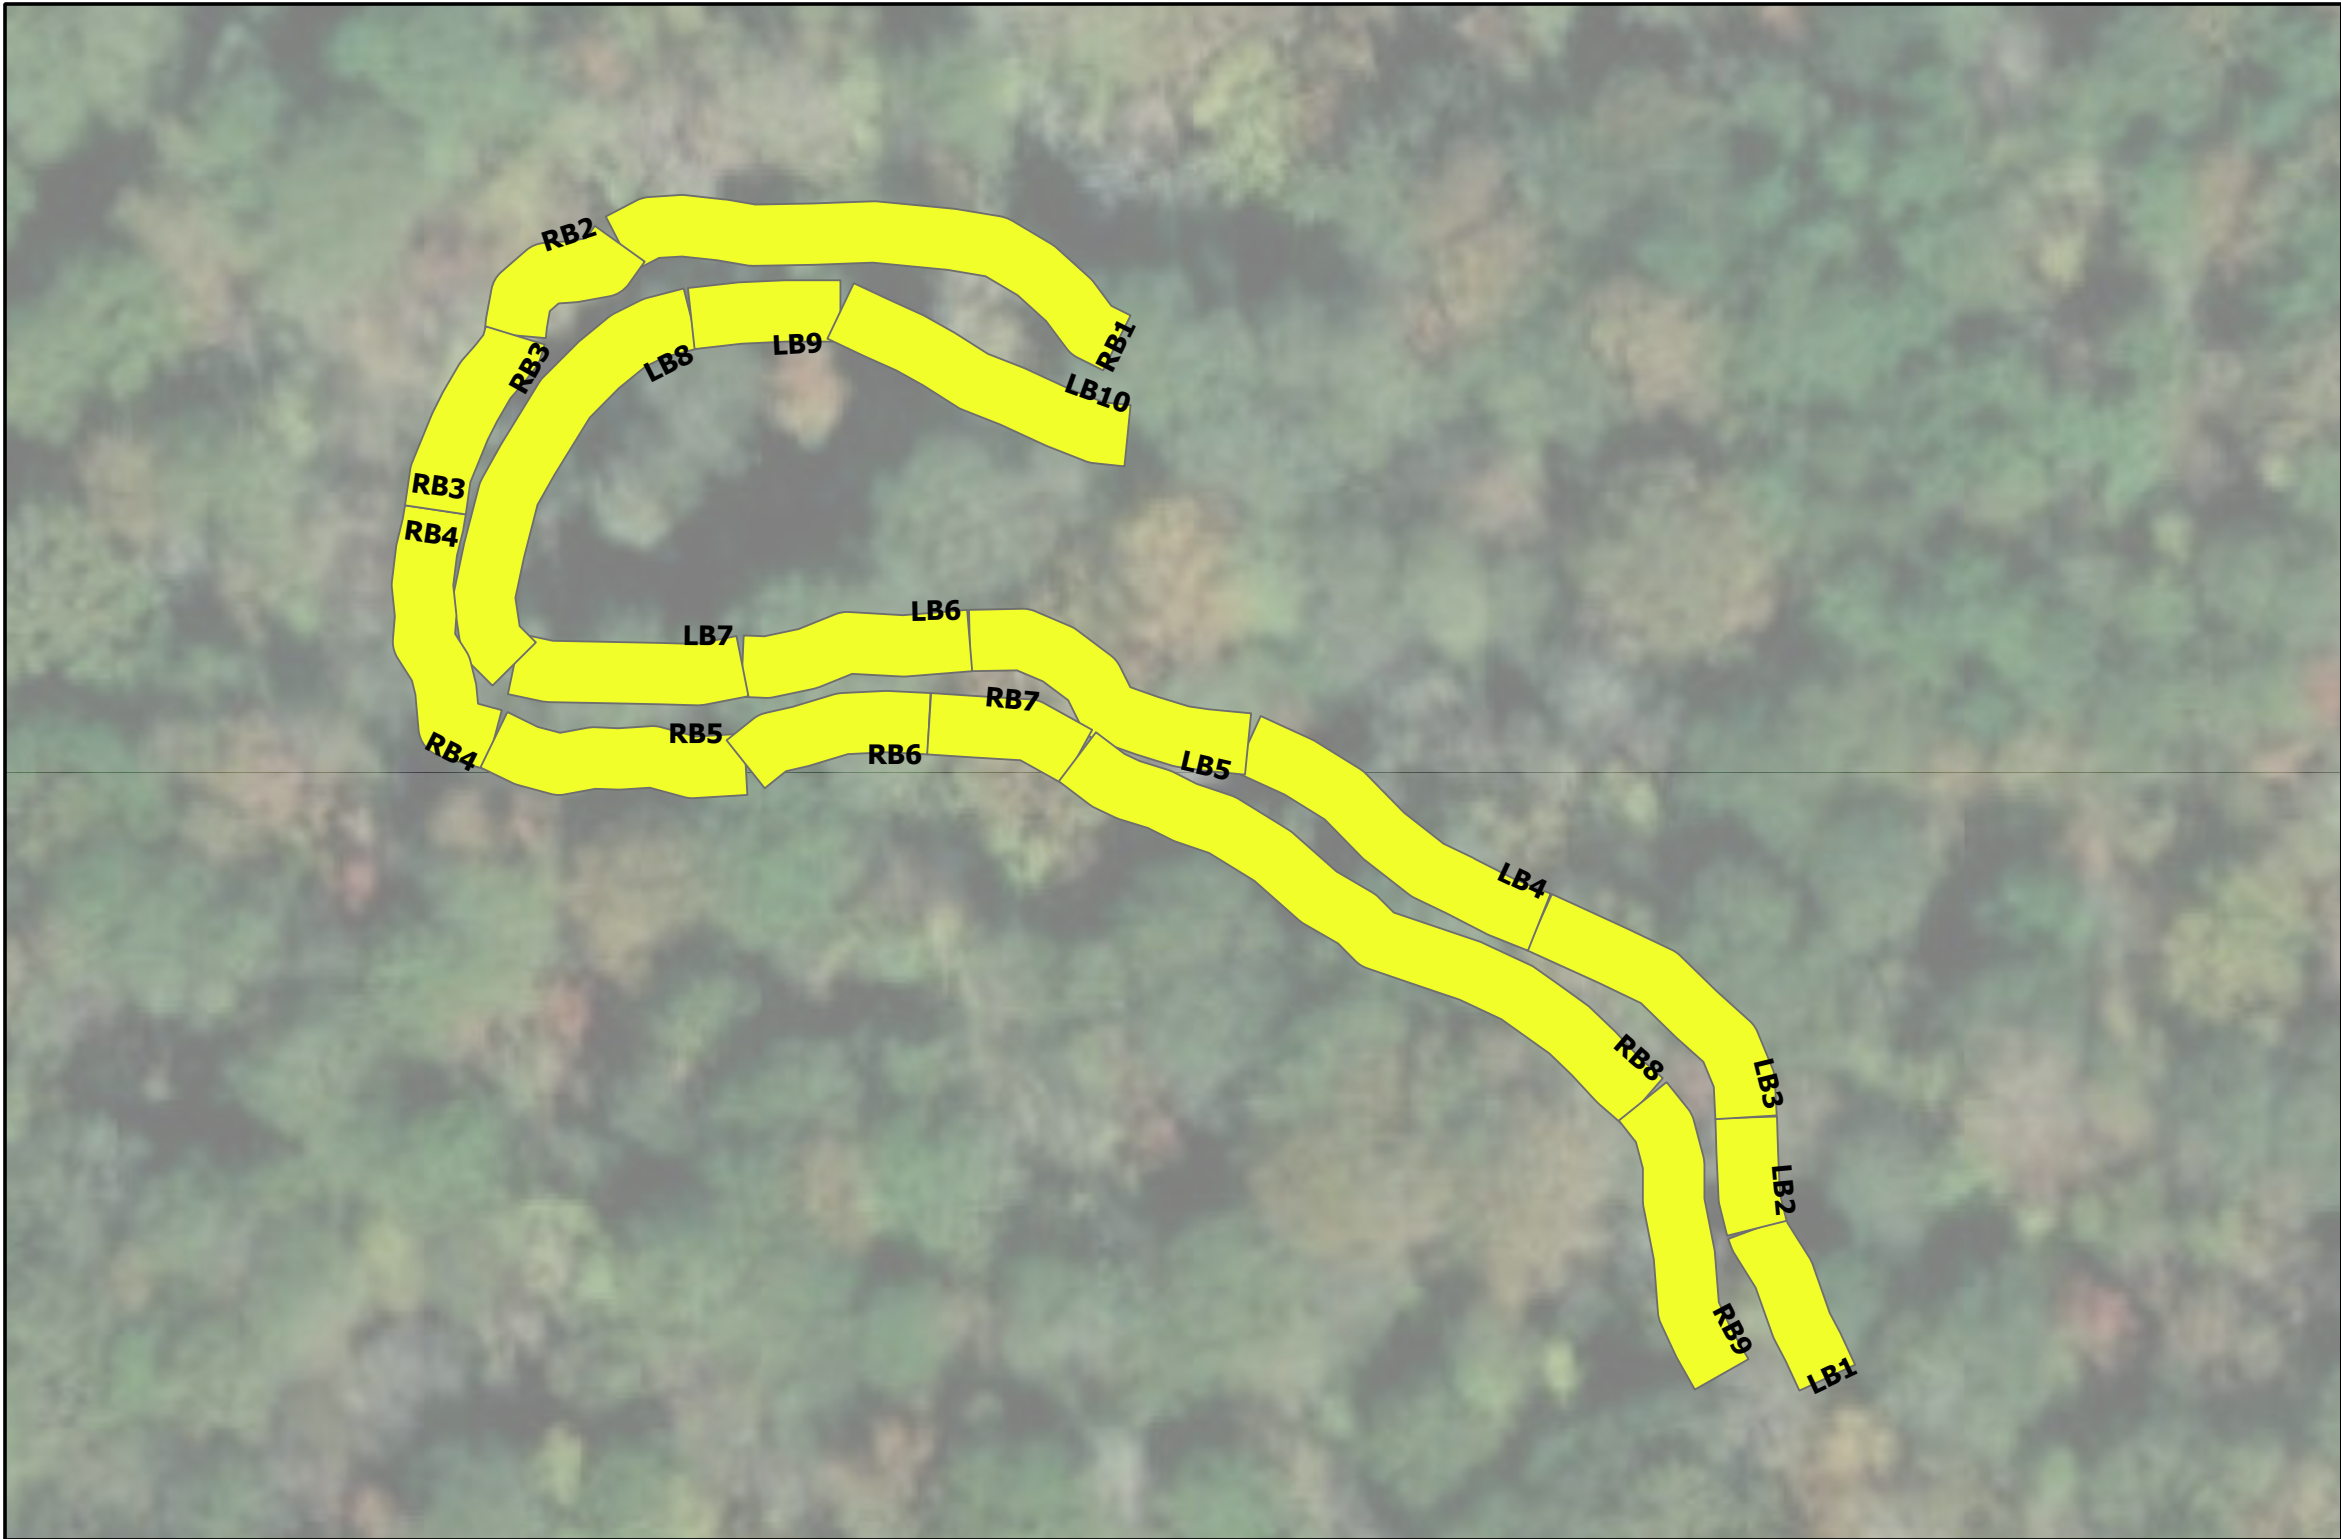
East Fork at Farm to Market Road 945 : Bank Data

Erosion Rate (ft/yr)	Category
0.030 - 0.070	1
0.071 - 0.13	2
0.14 - 0.64	3
0.65 - 1.3	4
Greater than 1.3	5

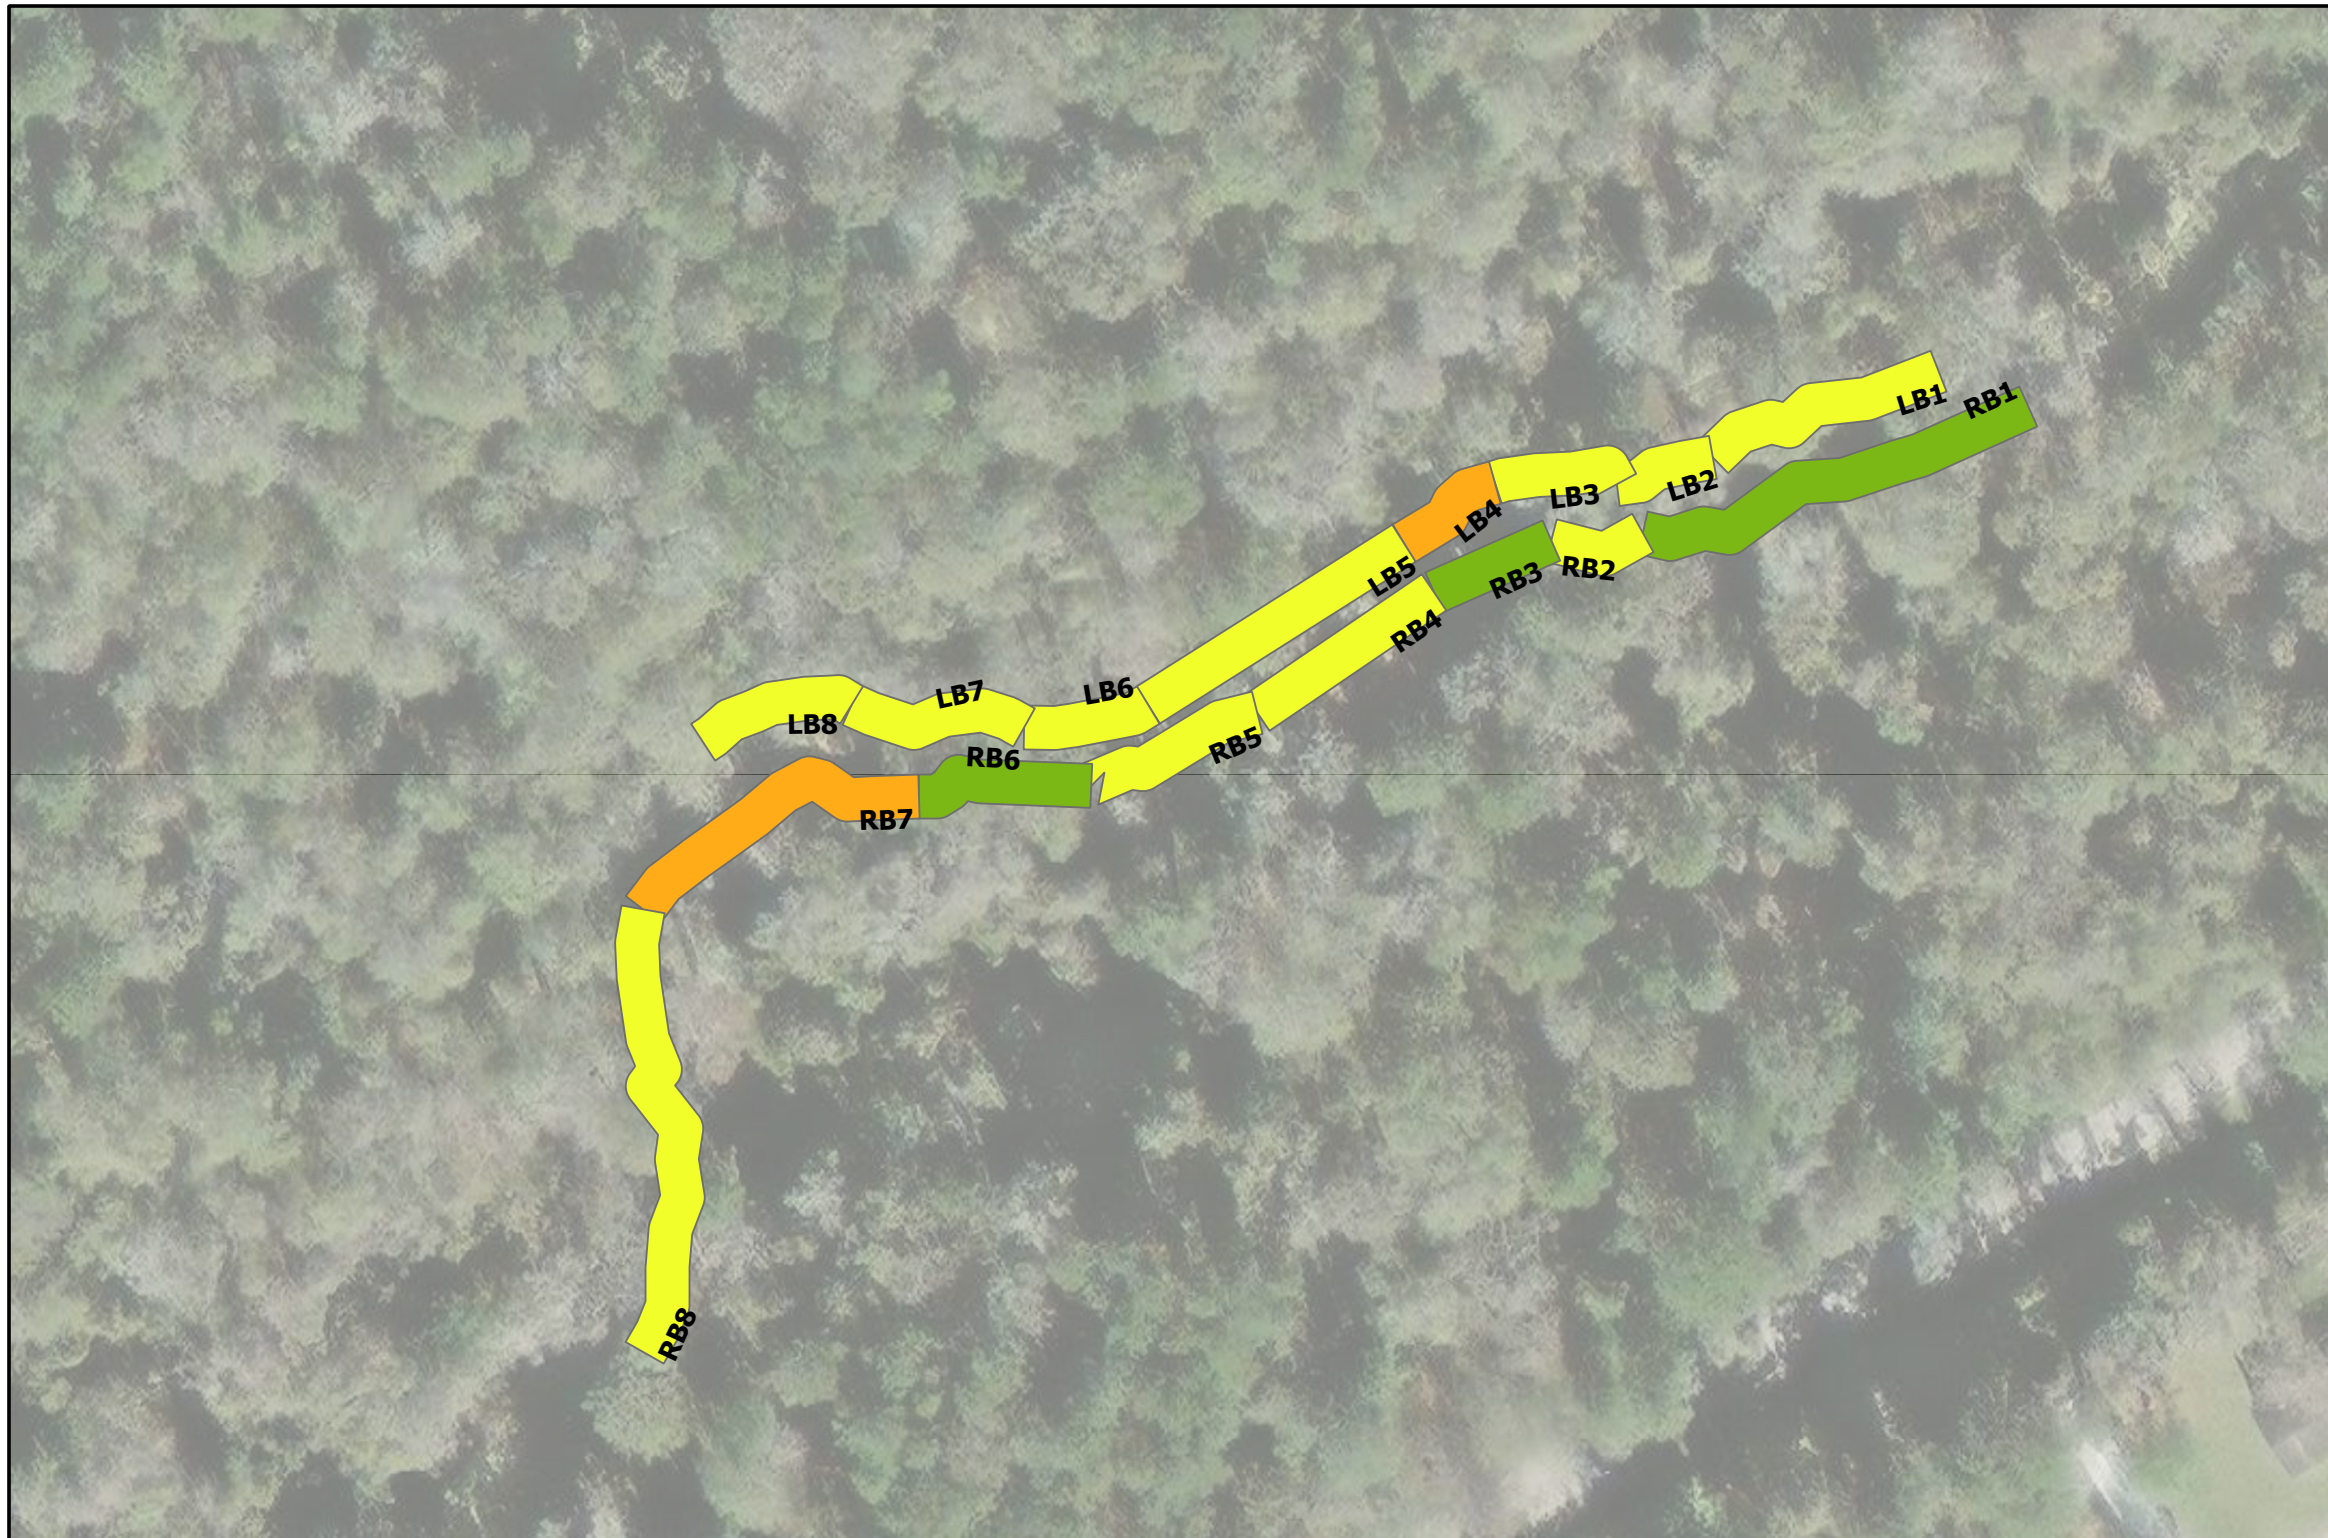
East Fork at Lower Vann Road : Bank Data

Erosion Rate (ft/yr)	Category
0.030 - 0.070	1
0.071 - 0.13	2
0.14 - 0.64	3
0.65 - 1.3	4
Greater than 1.3	5

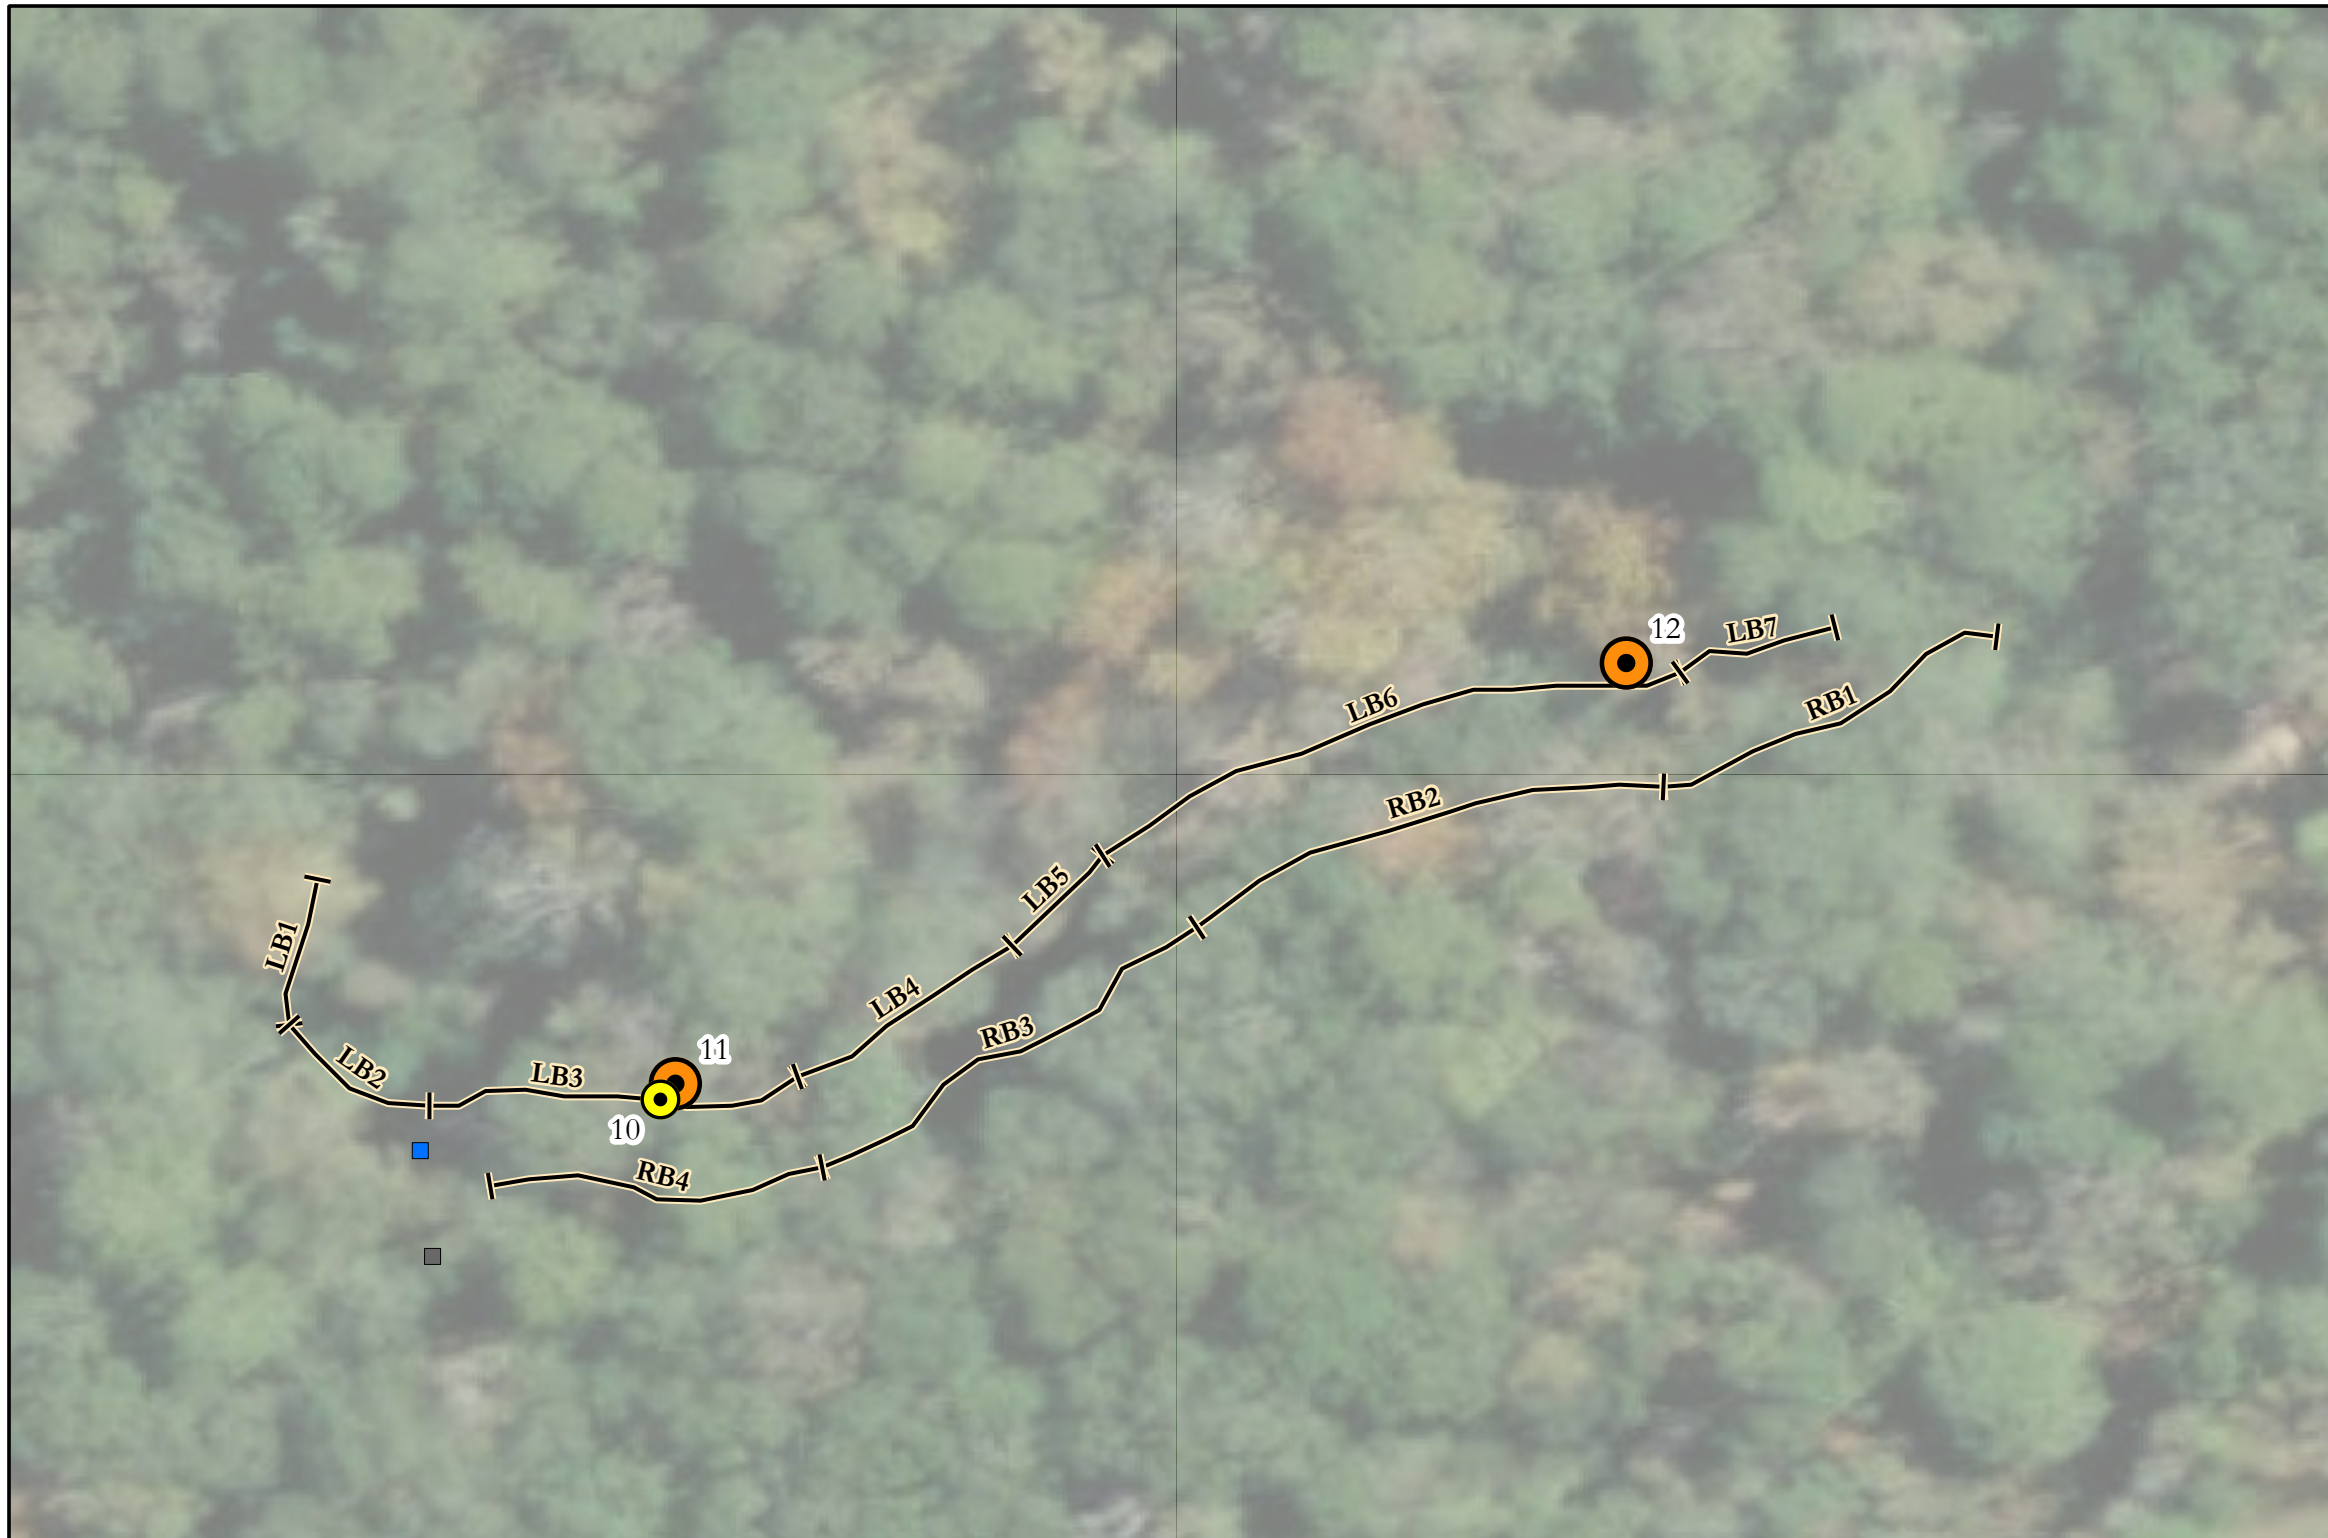
East Fork at SH150 : Dendrogeomorphic and Soil Sample Data

Erosion Rate (ft/yr)	Category
0 - 0.07	1
0.071 - 0.13	2
0.14 - 0.64	3
0.65 - 1.3	4
Greater than 1.3	5
