UPPER SAN JACINTO RIVER BASIN REGIONAL SEDIMENTATION STUDY

Technical Memorandum 3

Annual Sediment Supply and Storage

December 2023

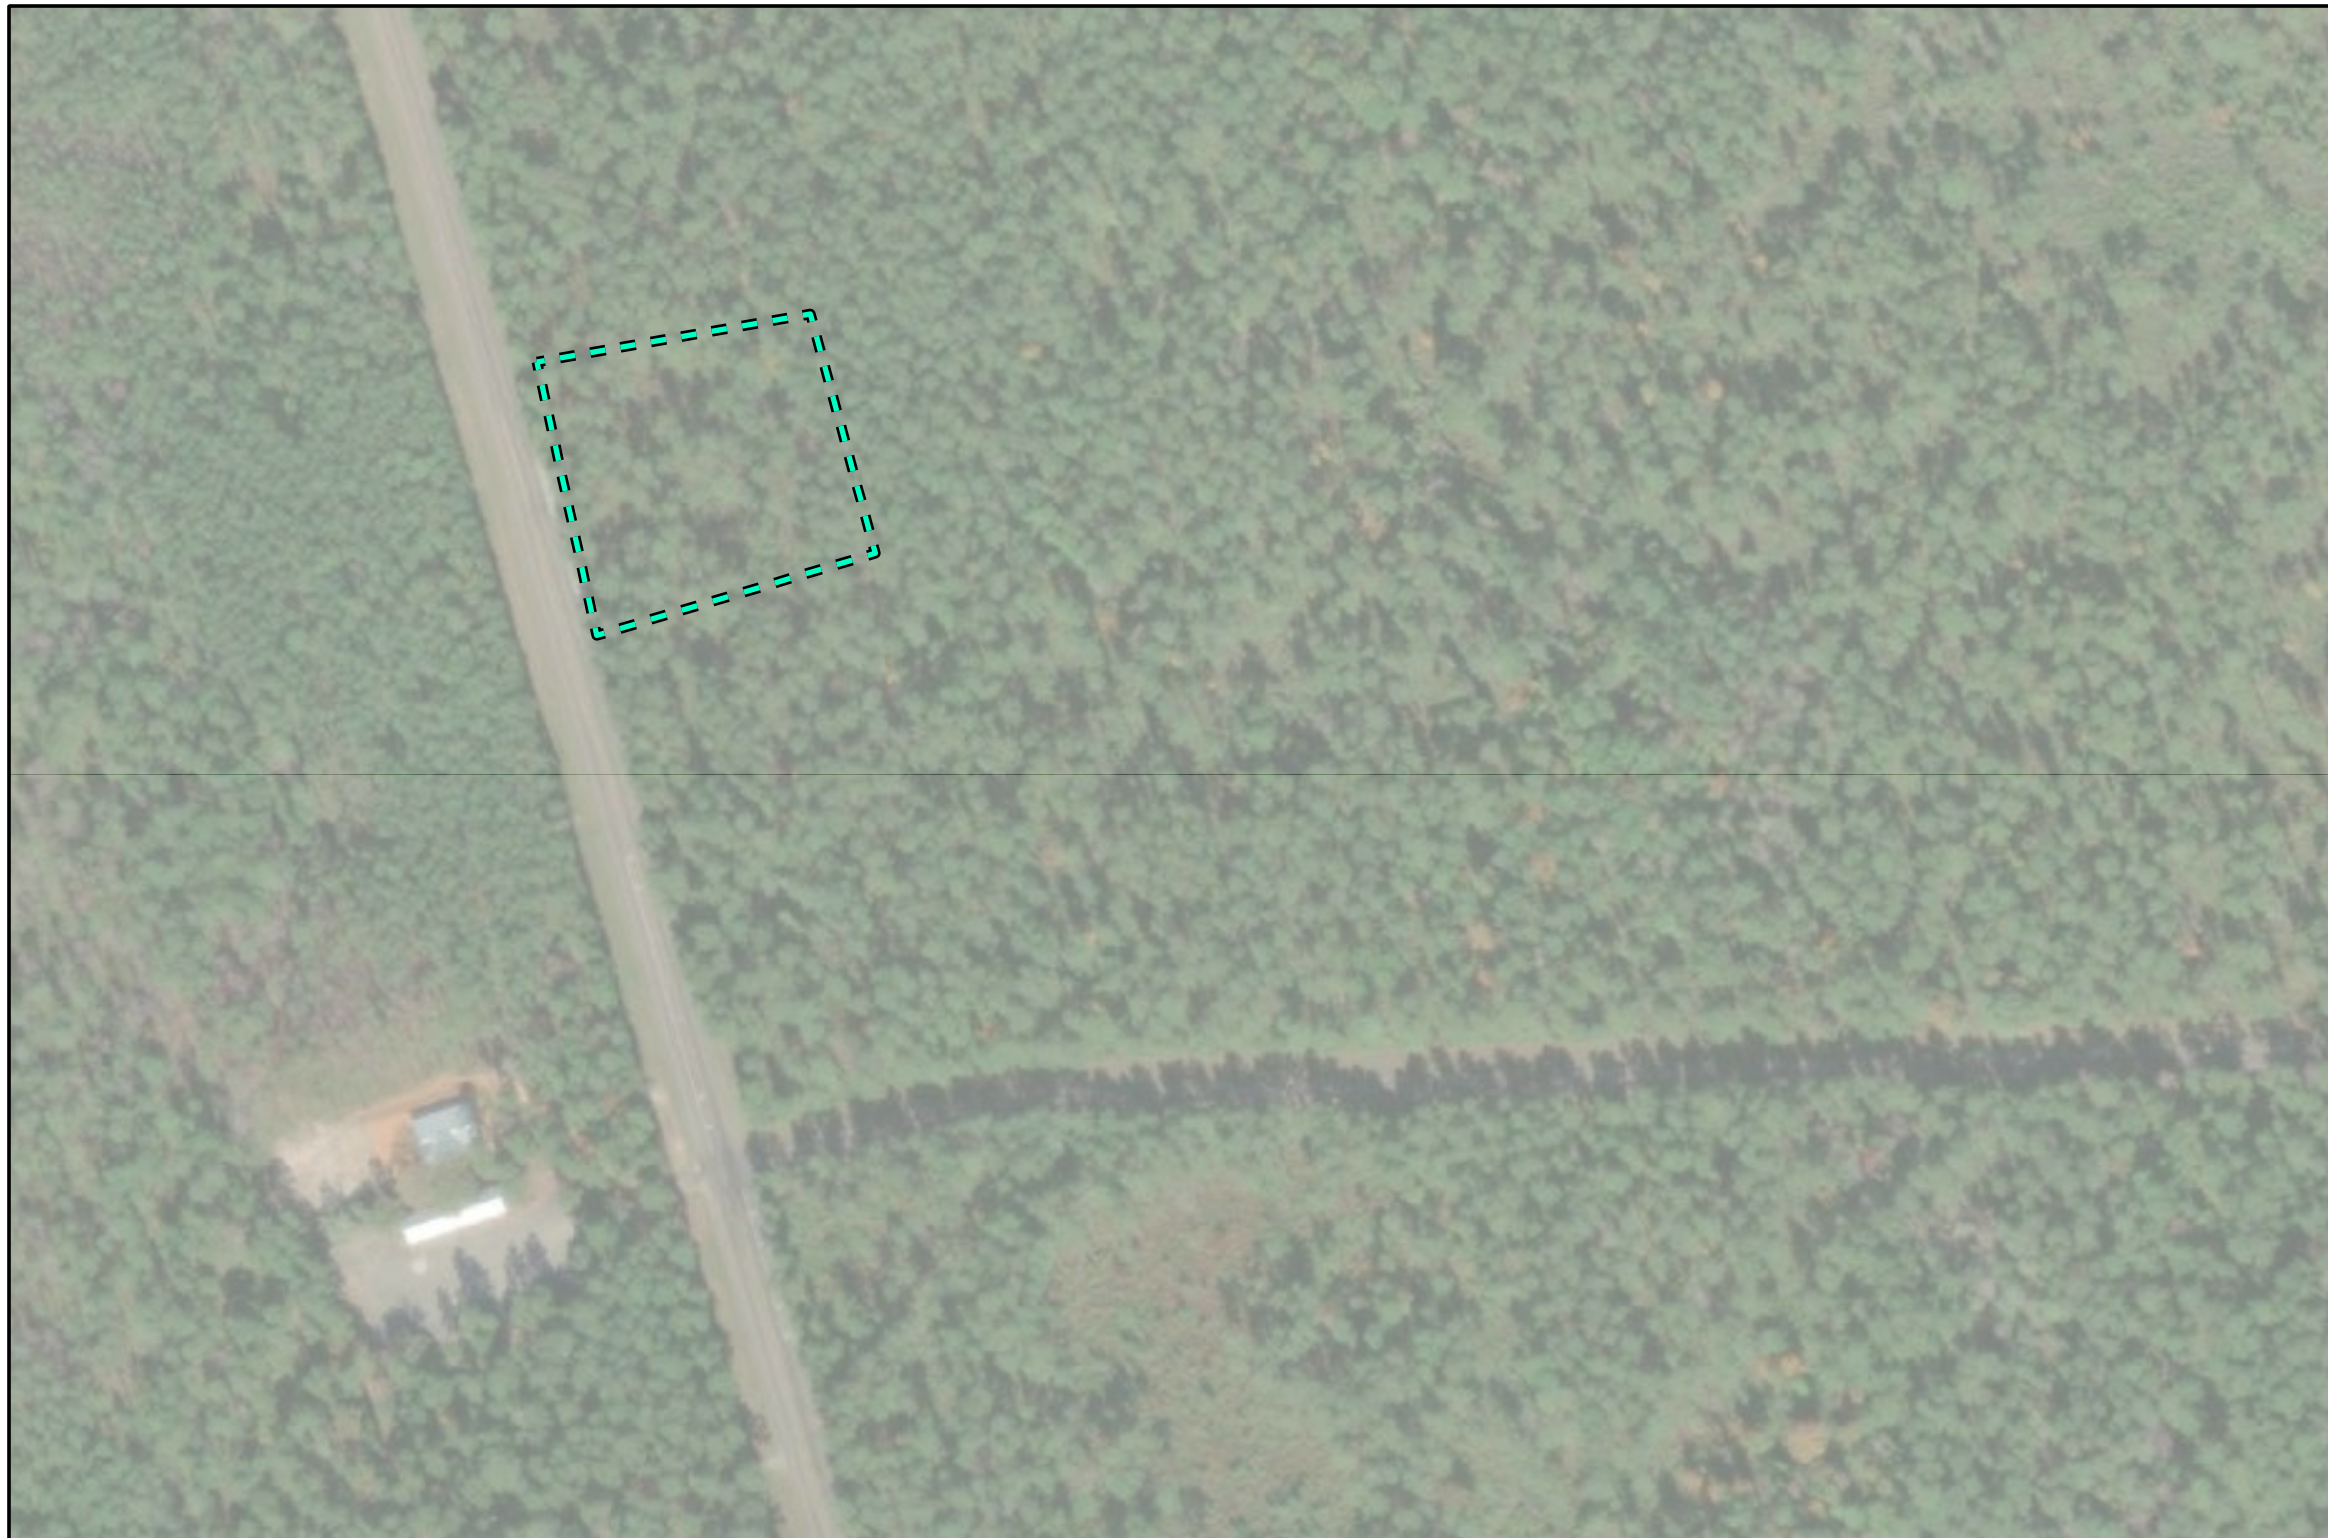
East Fork at Lower Vann Road : Dendrogeomorphic and Soil Sample Data

Erosion Rate (ft/yr)	Category
0 - 0.07	1
0.071 - 0.13	2
0.14 - 0.64	3
0.65 - 1.3	4
Greater than 1.3	5
